Manhole Inspection Summary

Manhole # S69C__004MH

Insp Date: **3/19/10 11:41 AM**

Location Address: **Kane St.**

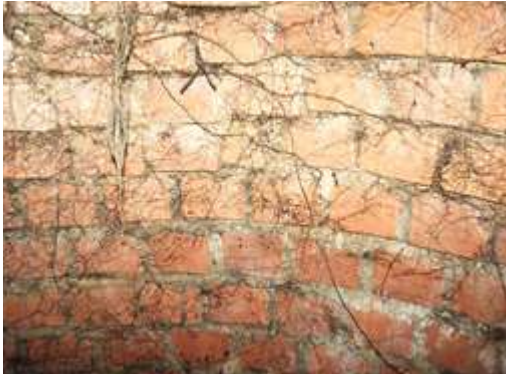
Defect 3

roots

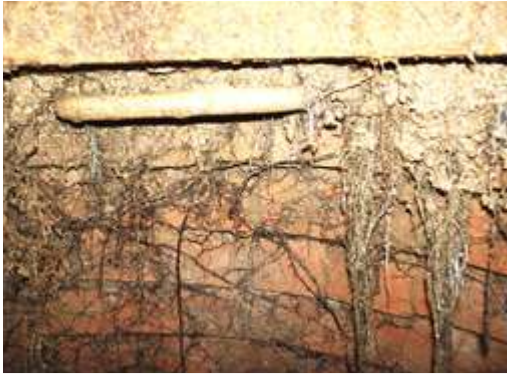
Defect 2

roots

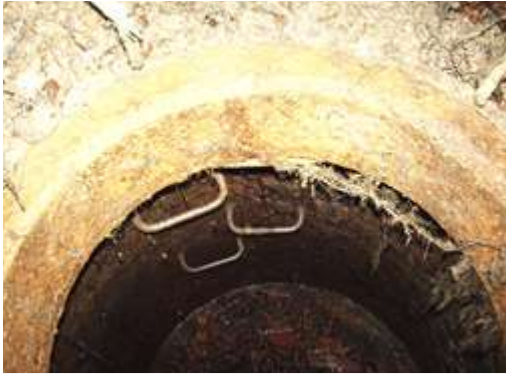
Defect 1

frame leaks

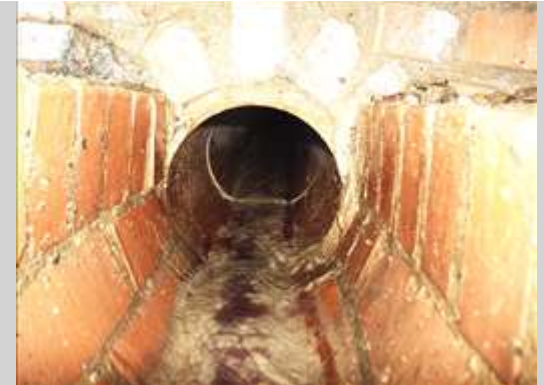
12 O'Clock Outflow

8 in. Circular Gravity Sewer
Pipe Out @ 12 O'Clock

Pipe Height: **8.4** (in.) Rod and Bar (Angled)
Pipe Material: **Clay** ☐ Pipe Lined
Invert Depth: **8.25** (ft.) Flow Characteristics: **Slow**
Deposits: ☒ None ☐ Mud ☐ Sludge ☐ Debris ☐ Grease
Silt Depth: (in.) Deposits Extent:
Infiltration: **None** Pipe Seal Cond: **Sound**

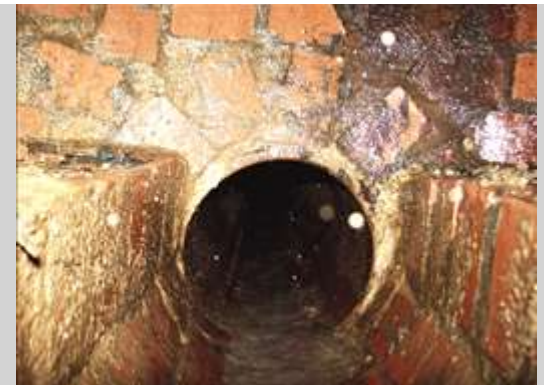
5 O'Clock Inflow

8 in. Circular Gravity Sewer
Pipe In @ 5 O'Clock

Pipe Height: **8.4** (in.) Rod and Bar (Angled)
Pipe Material: **Clay** ☐ Pipe Lined
Invert Depth: **8.00** (ft.) Flow Characteristics: **Slow**
Deposits: ☒ None ☐ Mud ☐ Sludge ☐ Debris ☐ Grease
Silt Depth: (in.) Deposits Extent:
Infiltration: **Evidence** Pipe Seal Cond: **Sound**
